CRITICAL SERVICE BULLETIN

CSB 02-2C

SUBJECT: STARTER ADAPTER SHAFT SEAL INSPECTION

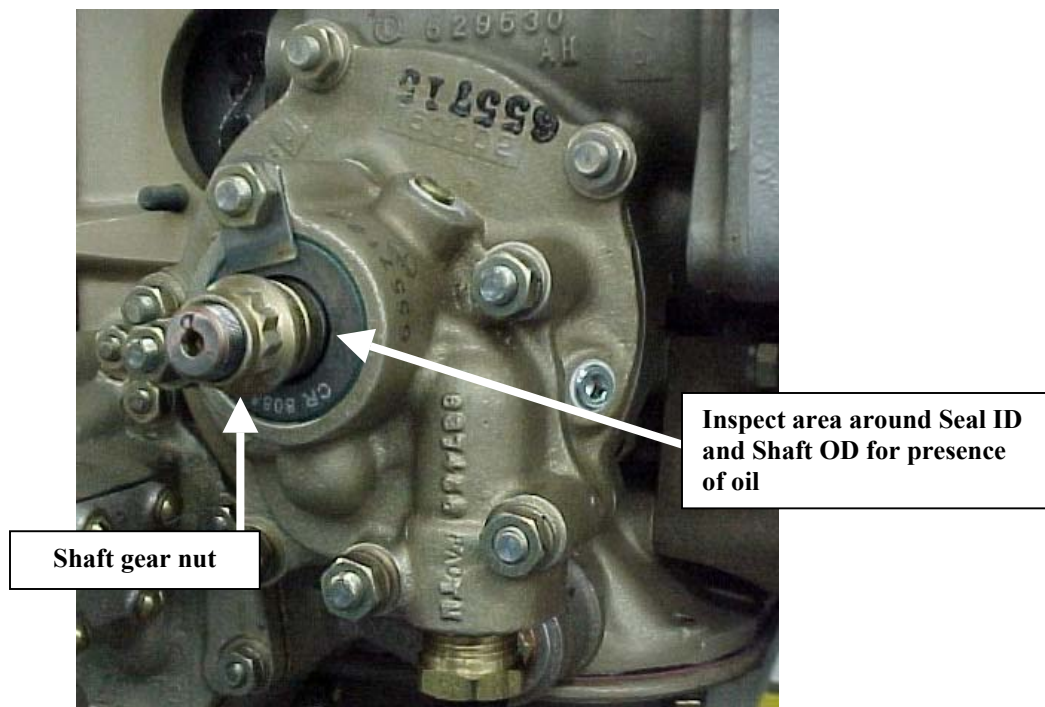
FIGURE 1
P/N 642087A XX Starter Adapter

Service Bulletin does not apply. If the starter adapter installed on your engine does have a shaft extending past the rear cover of the starter adapter (Figure 1), inspect the area around the oil seal ID and the starter adapter shaft OD for the presence of oil that may indicate a shaft issue.

If there is oil present, determine if the starter adapter shaft gear has fractured by attempting to rotate, in a clockwise direction, the shaft gear using the correct size 12 point wrench or socket engaged on the shaft gear nut. Reference Figure 1.

If the shaft gear nut does not readily turn or results in the engine and propeller rotating, the shaft gear is not fractured. Determine the source of the oil and take appropriate correction action.

If the shaft gear turns with a minimal amount of force, the shaft gear is fractured and the starter adapter will require replacement prior to further flight.

Starter adapter replacement to be accomplished in accordance with the applicable engine maintenance or overhaul manual.

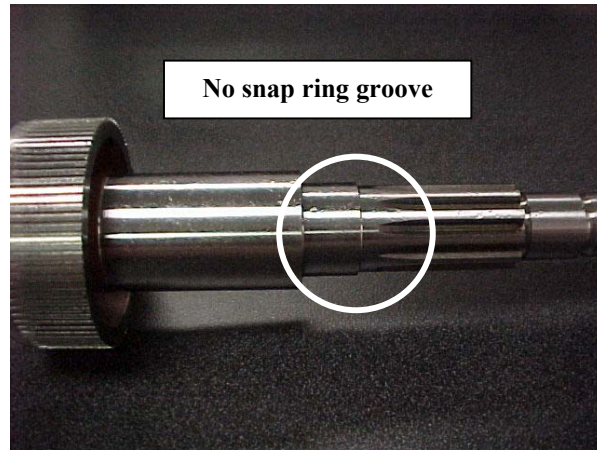
FIGURE 2
655711 Shaft Gear

Teledyne Continental Motors has verified the breakage of 7 part number 649866 starter adapter shaft gears. The fractures originate in the machined circlip groove forward of the shaft gear oil seal installed in the scavenge pump housing. Analysis of the fracture area indicates initiation resulted from misalignment of the scavenge pump housing to the starter adapter cover.

The starter adapter shaft gear P/N 655711 replaces shaft gear P/N 649866. The P/N 655711 shaft gear does not have the snap ring groove machined just aft of the first shoulder as noted in Figure 2.
