TCM SB08-12 and The Classic Starter Adapter Interference Problem

by Tom Carr

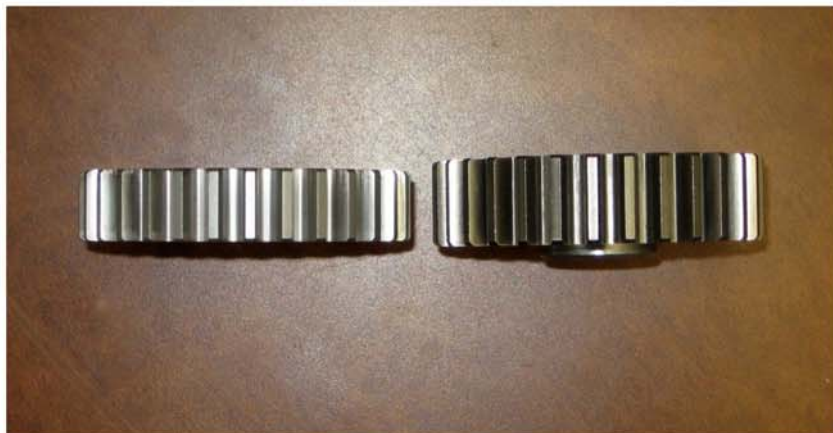
The gear on the left is the old style while the gear on the right is the 657175 part number configuration. The increased height in the new gear is very obvious. The gear bolts hitting the Classic starter adapter is very possible and clearance must be checked.

engine when compared to the earlier starter adapters which are commonly referred to as classic designed. So during an engine overhaul or maintenance action when your engine gets the new wider crankshaft gear and if you still have a classic starter adapter, there is a very good chance the friction collet will hit the crankshaft gear retaining bolts. Finding this out before the engine is started would be the preferred option rather than seeing all the metal in the oil screen or filter and trying to figure out where all that ferrous metal is coming from.

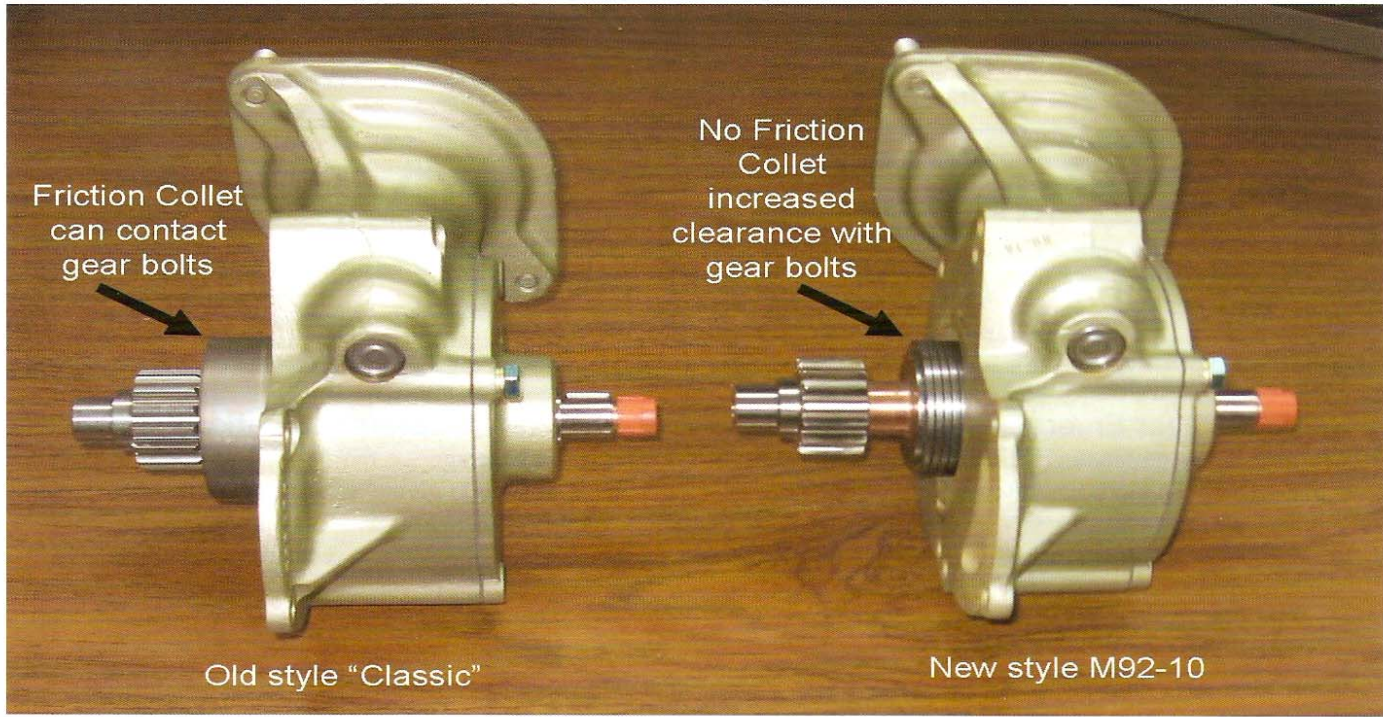
"If crankshaft gear P/N 657175 is fitted with an old type adaptor P/N 635050A() () per the instructions in SB08-12 the CAA recommends the following assembly procedure and inspection to check for interference between the crankshaft gear attach bolt heads and the clutch spring adapter housing sleeve, before starting the engine.

Fit the starter adapter to the crankcase by pressing into position by hand. Do not use the attachment bolts to pull the starter adaptor into place. With the adapter in position fit and tighten the attachment bolts. Before starting the engine, turn the engine over one complete revolution by hand and determine whether there is any interference between the crankshaft gear attach bolts and the adapter housing. If any interference is found contact the engine manufacturer for corrective action."

At this point in time CPA has heard the corrective action comment coming back from TCM says; replace the starter adapter as called out in M92-10 with the new design configuration.
